Port Townsend Bay Eelgrass Survey

July 18, 2015

Ian Fraser

***Marine
Resources
Consultants***

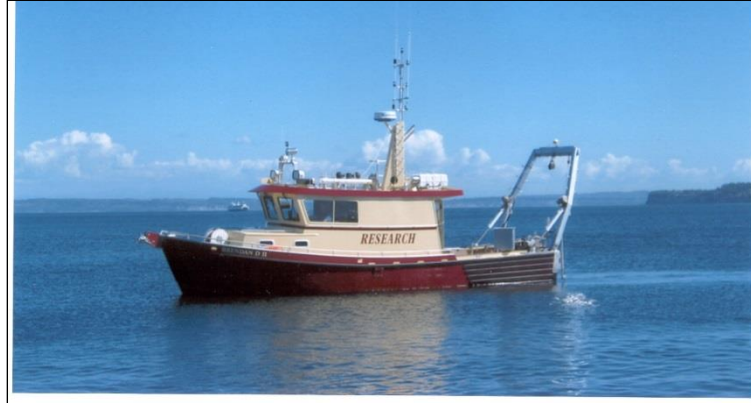
We conducted sampling aboard the 36-ft *R/V Brendan D II* (Fig. 3). We acquired position data using a sub-meter differential global positioning system (DGPS) with the antenna located at the tip of the A-frame used to deploy the camera towfish. Differential corrections were received from the United States Coast Guard public DGPS network using the WGS84 datum. A laptop computer running Hypack 2012 hydrographic survey software stored time,

Figure 3. The R/V *Brendan D II*.
